RE; MWRA Contract No. 6840 East Boston Branch Sewer.
Changed Condition ITI COR 11

Subj: **Pipe Preparation at Stations 10+23 and 20+93: East Boston Branch Sewer Rehabilitation,**
MWRA Contract No. 6840

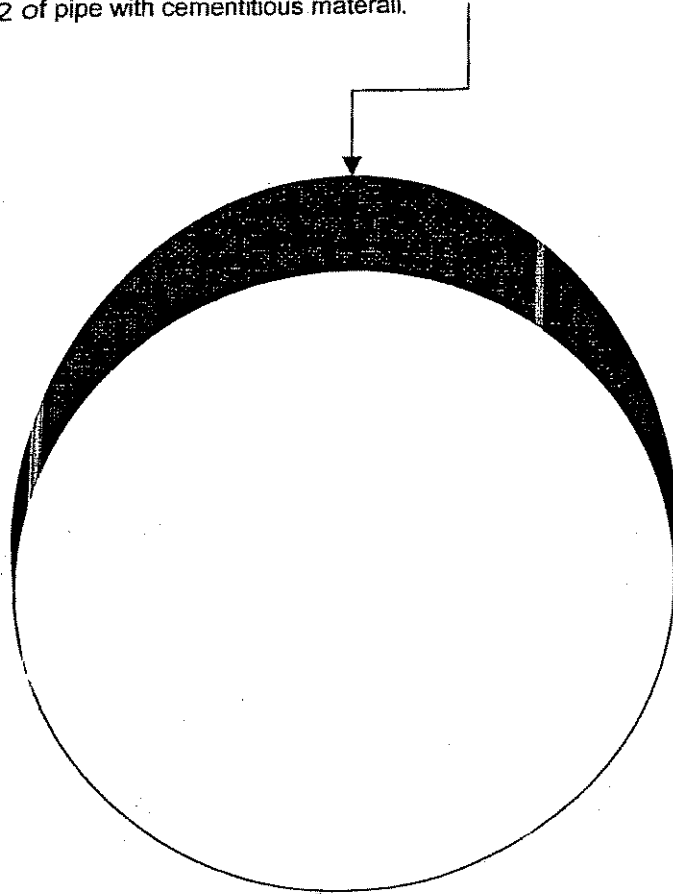
As we discussed yesterday, based on our field measurements and observations the pipe was constructed with a taper on the downstream side of the manhole at station 20+93. A similar situation appears to be the case (although to a lesser extent) at manhole 10+23; however, additional measurement and investigation following bypass startup and initial cleaning is advised.

At manhole 20+93 we recommend that the taper area be "filled" with 4" to 6" of cementitious material at the crown prior to lining to bring it to 39.2" (minus zero, plus ½") equivalent diameter. The material should be applied only in the top half of the pipe to provide a smooth and circular shape as generally depicted in the attached drawing.

We recommend that other areas confirmed to be 40.5" equivalent diameter (as a rule of thumb) or more be filled with cementitious material as described above. Please let me know if additional information will be helpful.

Fill top 1/2 of pipe with cementitious material.

Maintain existing flow line.
